**PRELIMINARY ASSESSMENT/
VISUAL SITE INSPECTION**

**ST. LOUIS AUTO SHREDDING, INC.
NATIONAL CITY, ILLINOIS
ILD 984 767 392**

FINAL REPORT

**U.S. ENVIRONMENTAL PROTECTION AGENCY
Office of Waste Programs Enforcement
Washington, DC 20460**

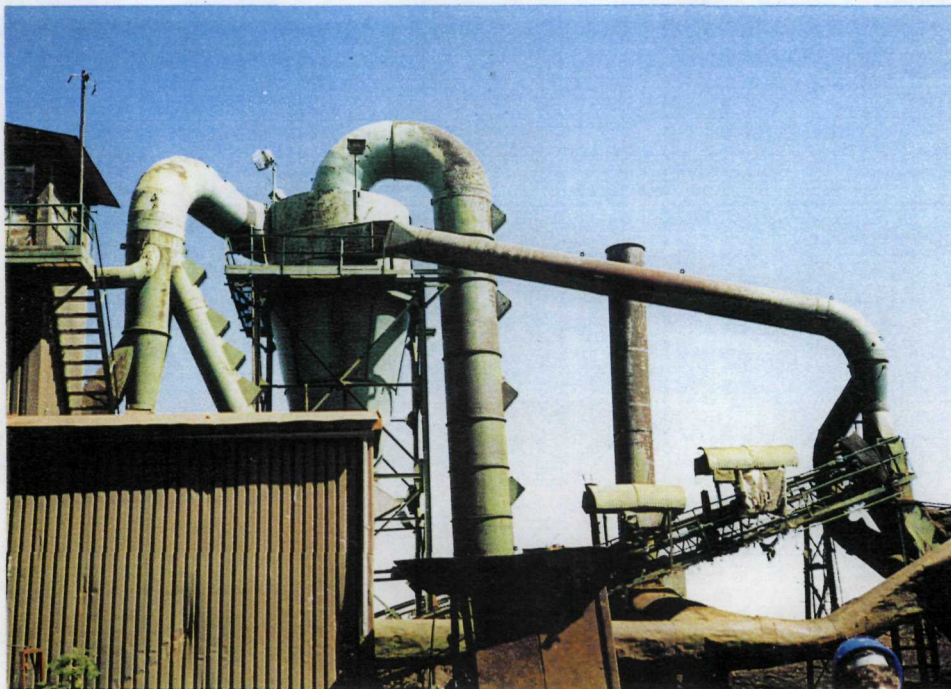
Photograph No. 1

Two cyclones with diameters of 14 and 16 feet are located on the ferrous separation side of the shredder (see Photograph Nos. 1 and 2). These cyclones have stacks and are permitted as air emission sources. The third cyclone is located on the nonferrous separation side of the shredder (see Photograph No. 9). The cyclones are 10 to 20 feet above the ground surface as shown in the photographs.

Location: SWMU 1

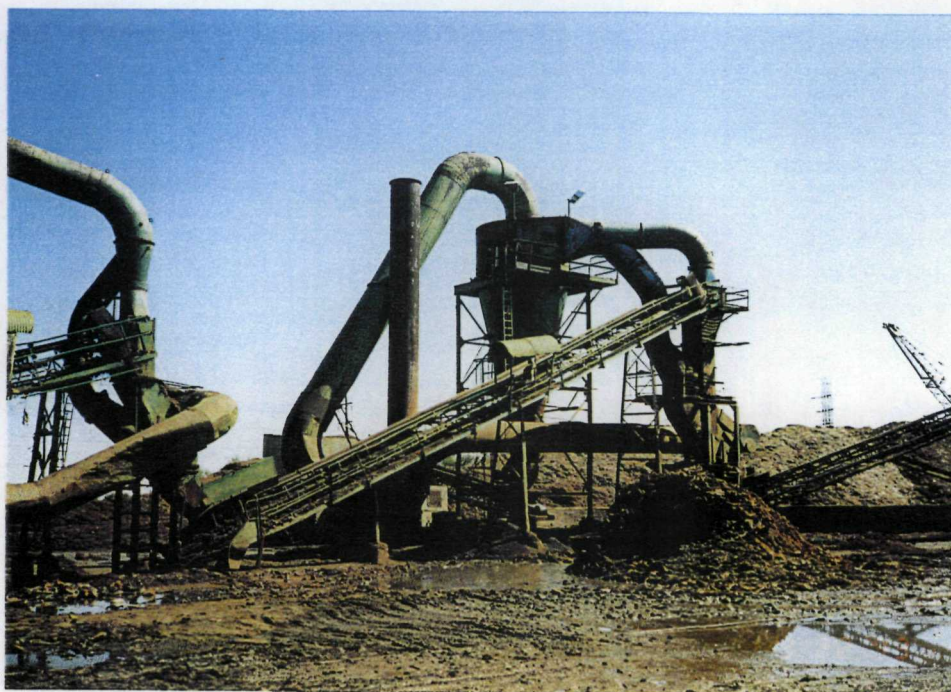
Photograph No. 2

Location: SWMU 1

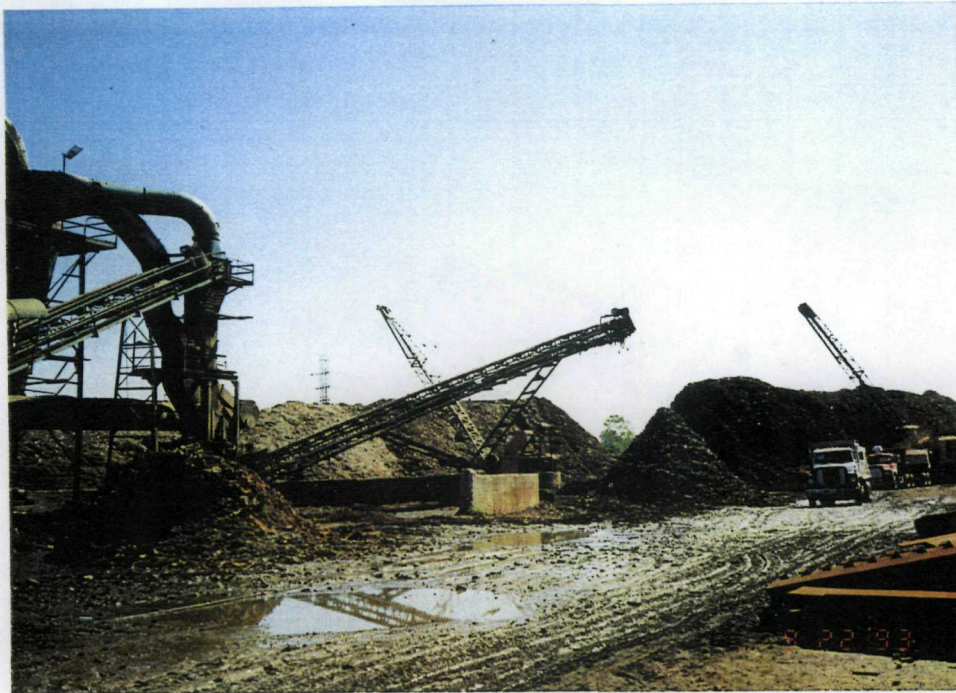
Photograph No. 3

Location: SWMU 3

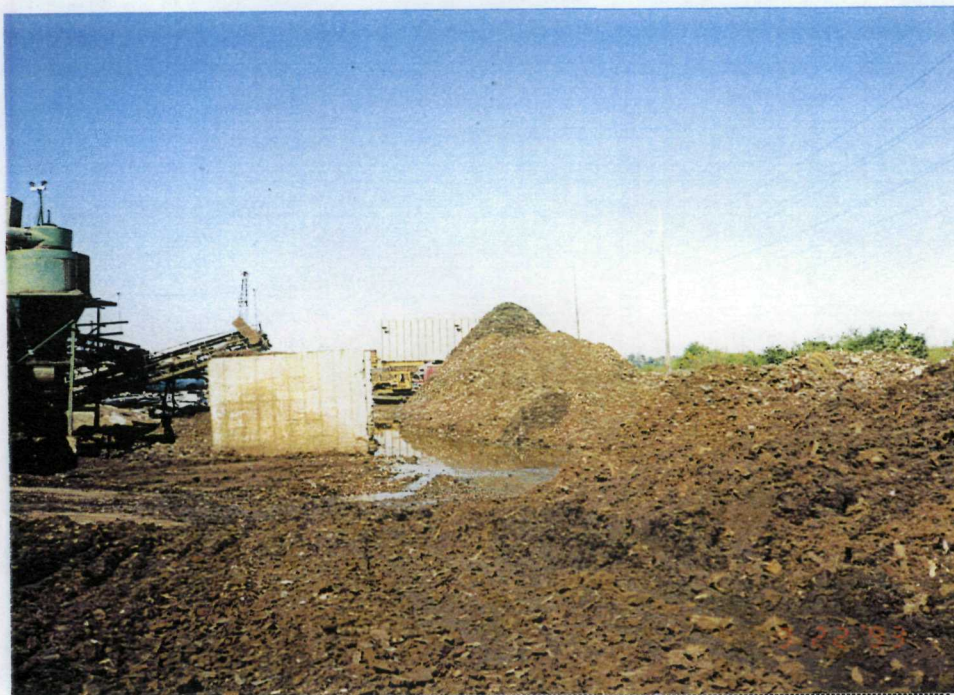
Photograph No. 5

Description: View of Auto Fluff Waste Piles to right of concrete retainer wall. Third cyclone is visible on left. The concrete retaining wall is part of the collection bin for auto fluff from the nonferrous separation area. Waste was standing in pooled water from recent rains.

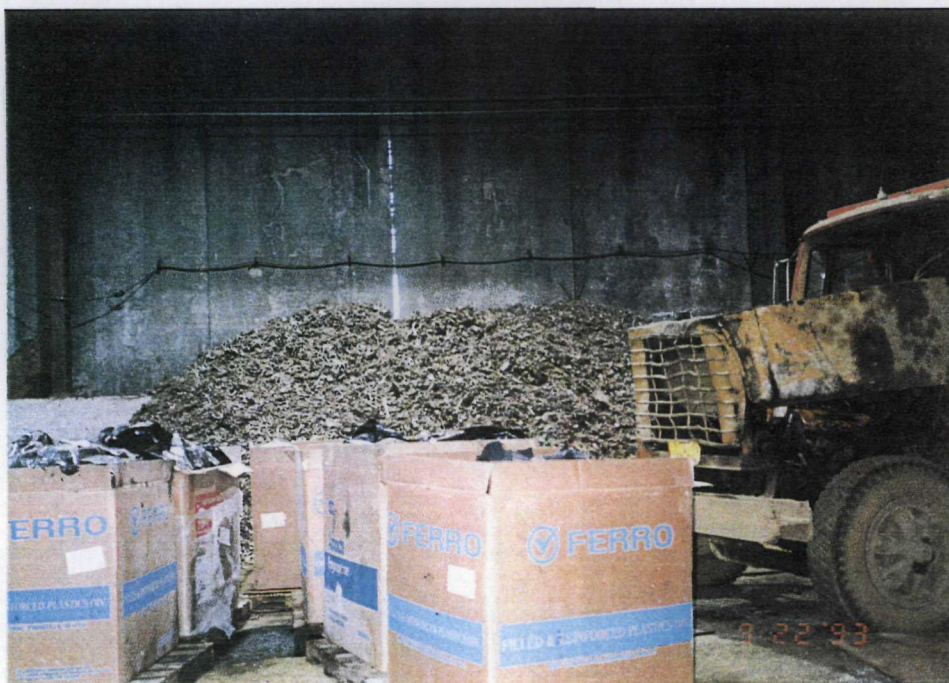
Photograph No. 6

Description: View of scrap recovered metal (background) in the media plant. Cardboard boxes contain scrap batteries waiting for sale.

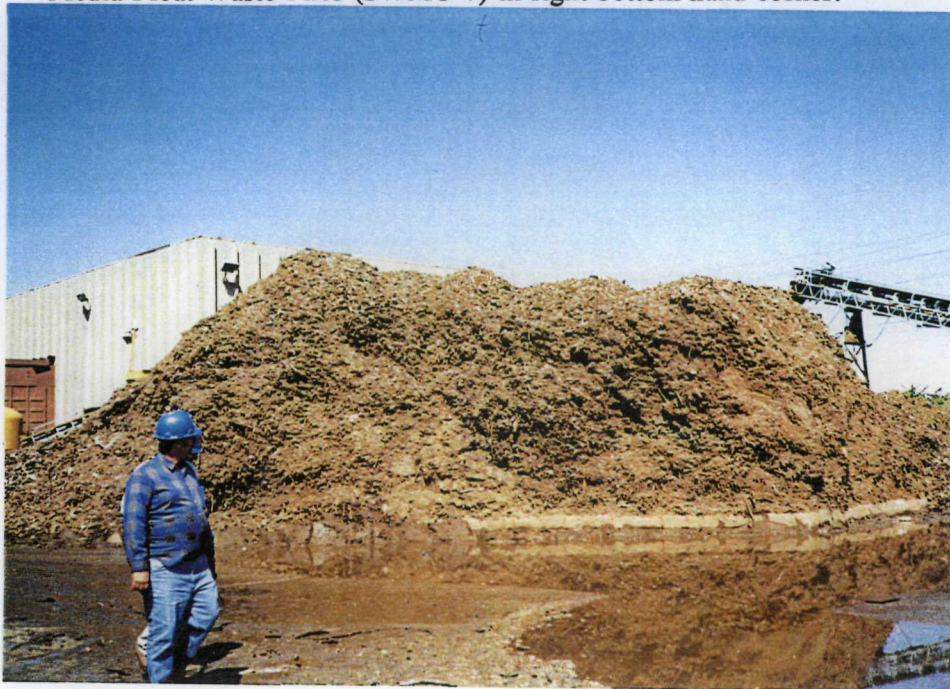
Photograph No. 8

Description: View of media float pile outside media plant. Part of waste pile is in standing water from recent rains.

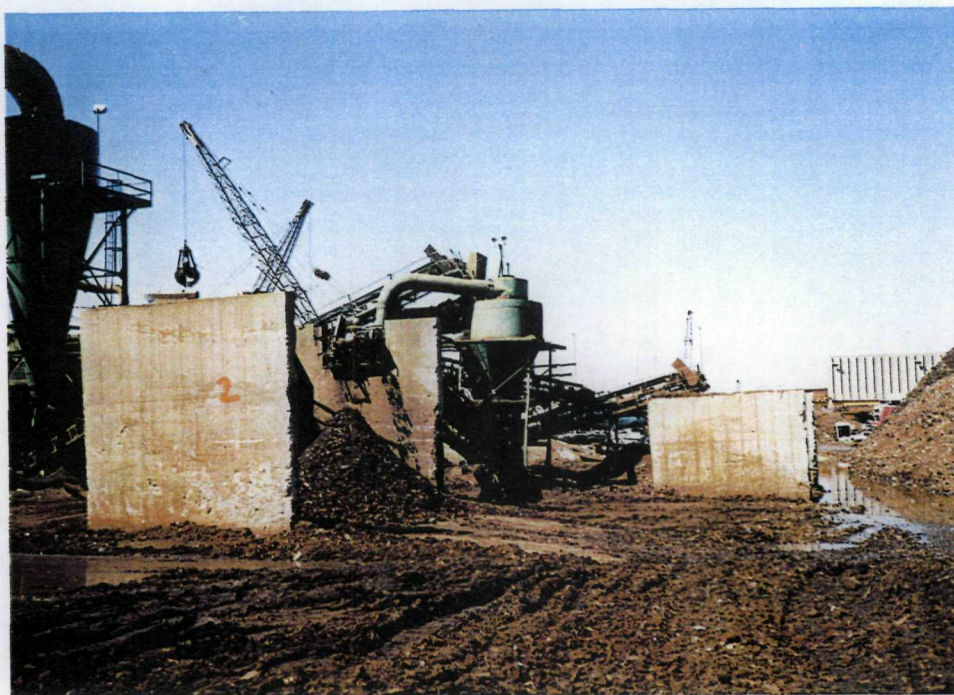
Photograph No. 9

Description: View of the collection bin for auto fluff from the third shredder at the nonferrous separation side of the shredder.

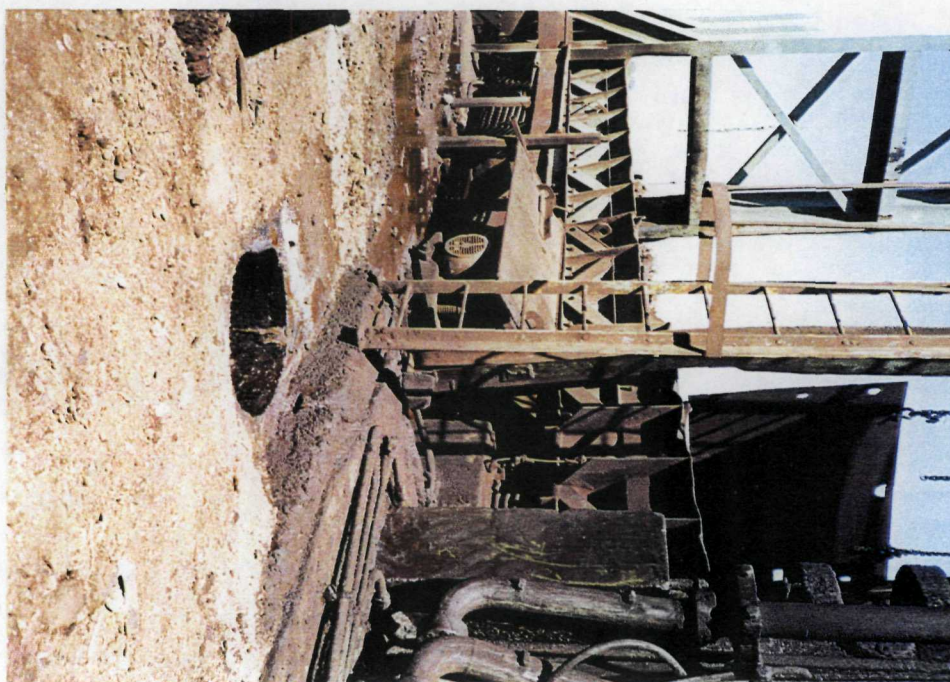
Photograph No. 10

Description: View of in-ground sump adjacent to shear. The sump is part of SWMU 5.

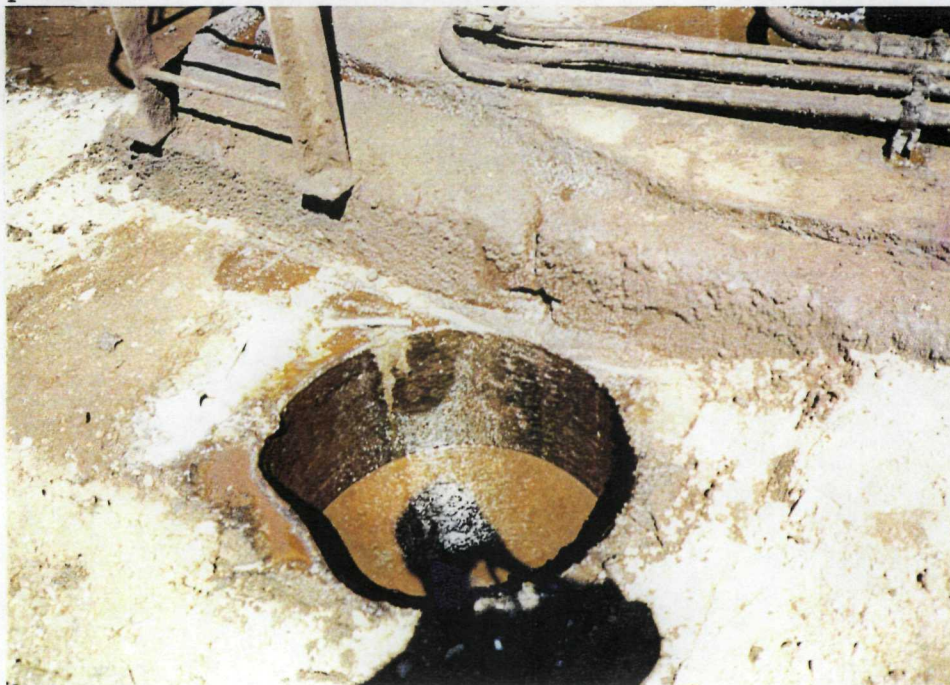
Photograph No. 12

Unit Description: This unit consists of a sump (see Photograph Nos. 10, 11, and 12), which is adjacent to the railyard shear and a portable metal unit (see Photograph No. 13), which is used for transferring waste oil from the sump to the Waste Oil Storage Area (SWMU 4).

Location: SWMU 5

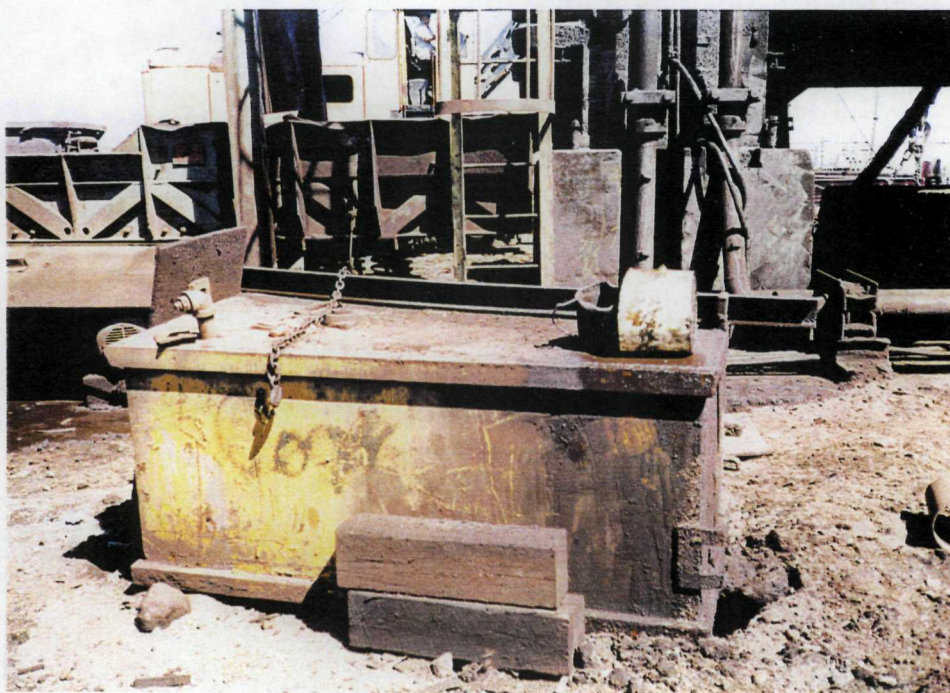
Photograph No. 13

drainage groove along the shear's side and from an outlet in the concrete base of the shear (see Photograph No. 13) across about 3 inches of ground surface to the sump. A wooden cover usually covers the sump. A portable metal unit measuring about 5 feet by 3 feet by 3 feet is used to transfer oil from the sump to SWMU 4. Ground surface surrounds the sump and underlies the metal transfer container.

Location: SWMU 5

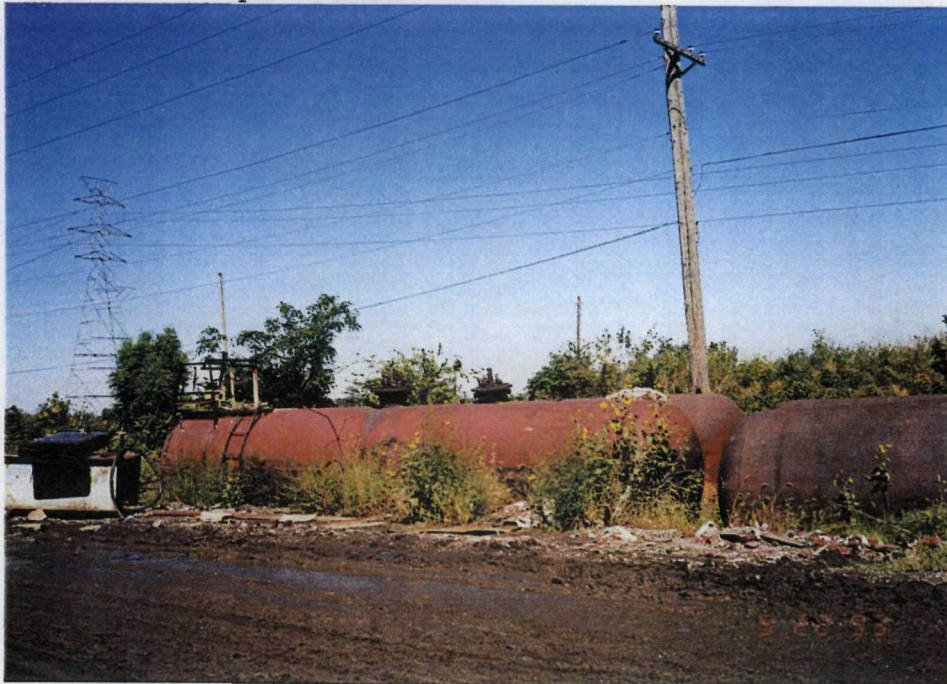
Photograph No. 14

This unit included five aboveground metal rail car tanks (see Photograph Nos. 14 and 15) which were located on the ground surface in the railyard area. The tanks each had a capacity of 11,000 gallons. These tanks were located northeast of the shear and north of the welding stations as shown in Figure 2.

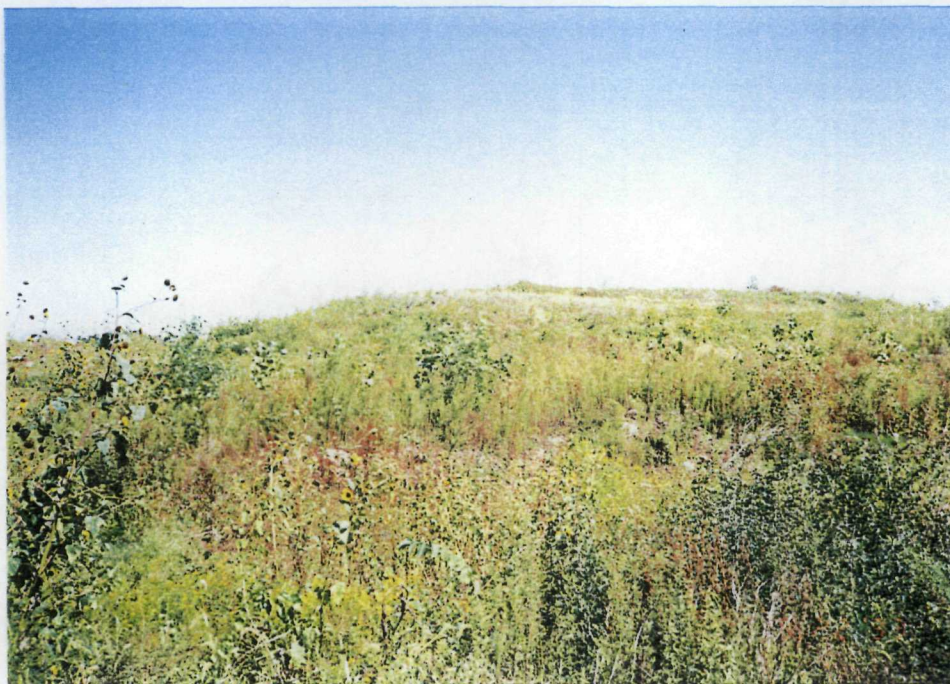
Photograph No. 16

Description: View of On-Site Landfill (SWMU 2), the northeast portion previously filled.

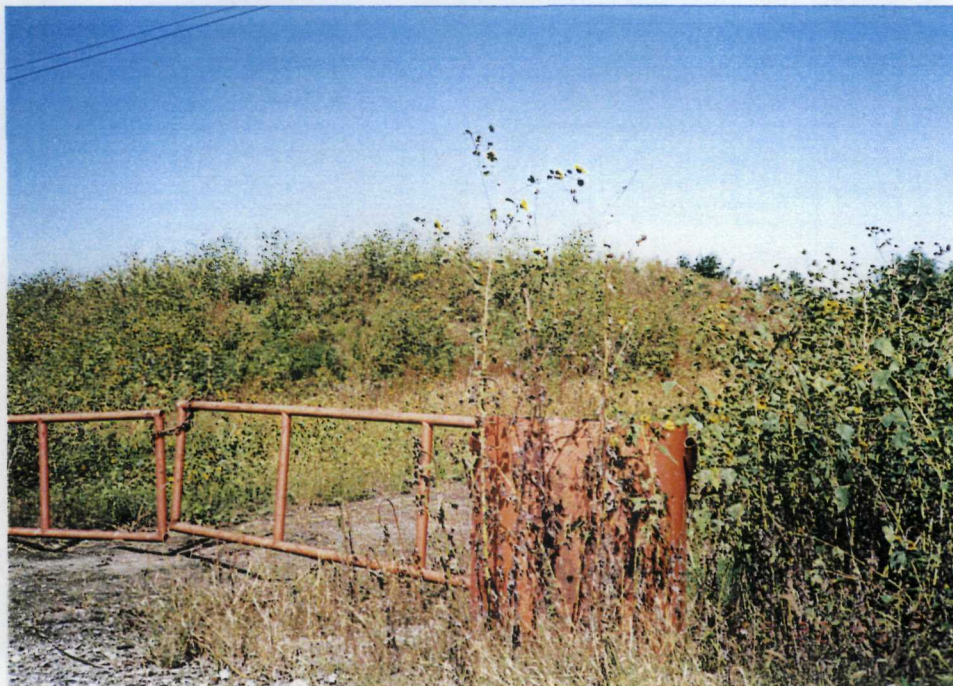
Photograph No. 17

Description: Second view of On-Site Landfill showing locked gate at entrance to landfill.

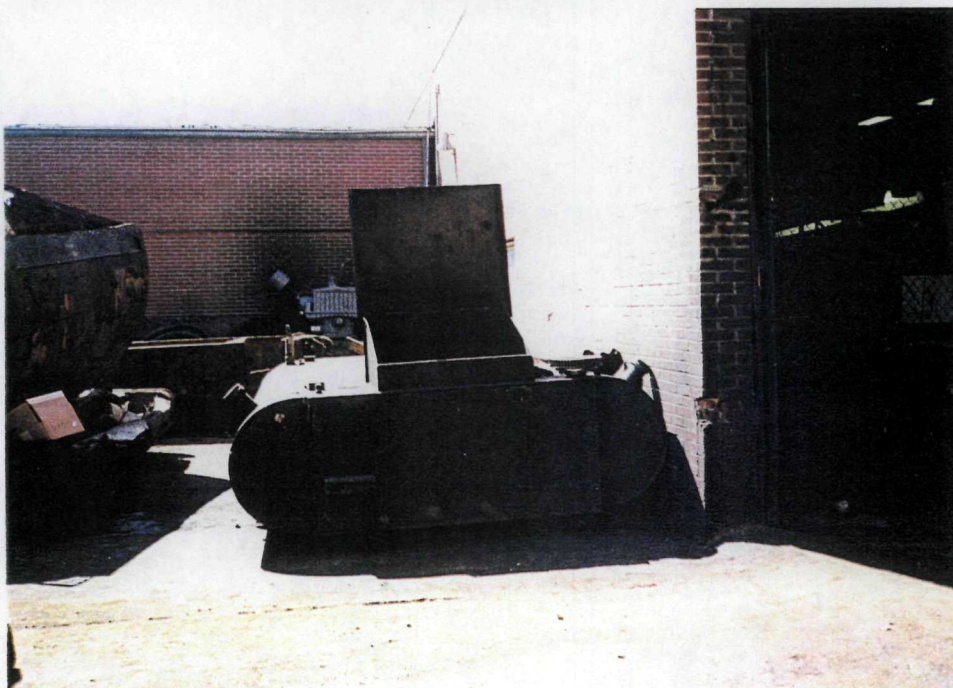
Photograph No. 18

Description: View of Waste Oil Storage Area locomotive tank (open top) used for waste oil storage.
